**Flood Control Project Maintenance
Levee Inspections**

Fall 2016 Levee Maintenance Deficiency Summary Report

Sacramento River Basin

Reclamation District No. 1001 Nicolaus

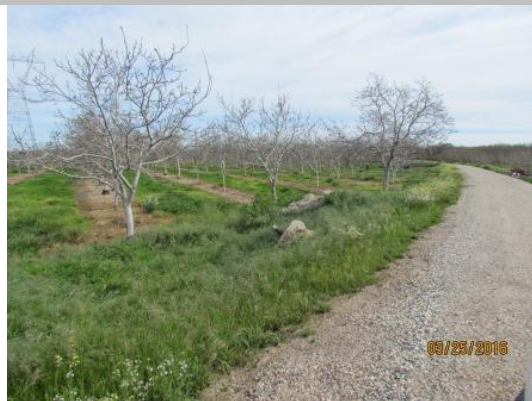
Photo 1 of 1 : FA_2016_RD1001_36_16_20160906_00011.jpg

LM Start	0.42	Rating **	M	Issue No.	16
LM End	0.42	Issue Type +	En	Location *	LS
Category	Earthen Levee			GPS Latitude/Longitude	
				Start	End
Item	Encroachments			38.975782 °	38.975782 °
				-121.475321 °	-121.475321 °
DWR ID	DWR_RD1001_01_s_2015_16				
Comment Code					
DE : Debris					
Inspector Comment

Concrete debris on landside slope looking downstream.

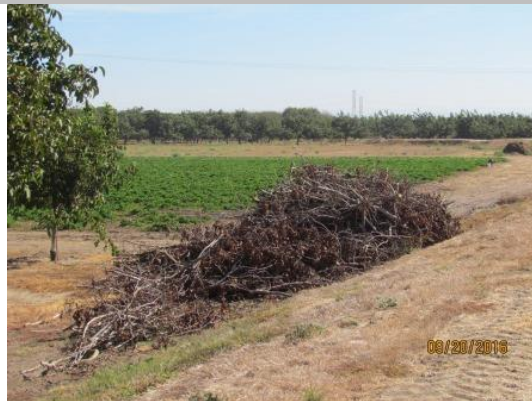
Photo 2 of 2 : FA_2016_RD1001_36_14_20160926_00018.jpg

LM Start	0.59	Rating **	M	Issue No.	14 (cont)
LM End	0.59	Issue Type +	En	Location *	LS

View of the prunings at the landside levee toe. Fall 2016.

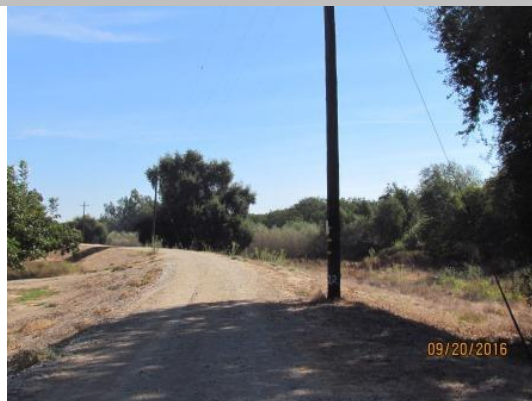
Photo 1 of 1 : FA_2016_RD1001_36_24_20160926_00028.jpg

LM Start	0.93	Rating **	A	Issue No.	24
LM End	1.55	Issue Type +	En	Location *	CR
Category	Earthen Levee			GPS Latitude/Longitude	
				Start	End
Item	Encroachments			38.974705 °	38.970573 °
				-121.484468 °	-121.494452 °
DWR ID	DWR_RD1001_01_f_2016_24				
Comment Code					
PO : Pole					
Inspector Comment					
Poles on landside crown and then they move over to the waterside slope.

View of a line of poles that start on the landside then cross over to the waterside at approximately half the length. This is looking upstream from the downstream end of the line. Fall 2016.

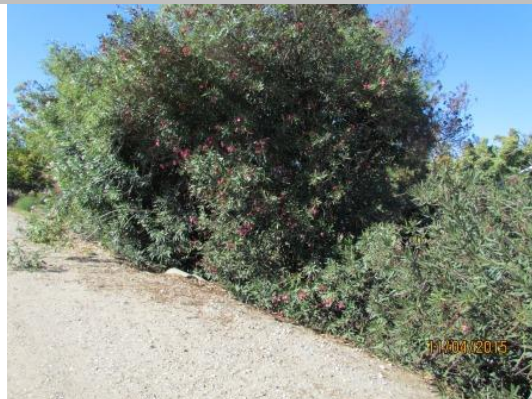
Photo 1 of 1 : FA_2016_RD1001_36_15_20160906_00010.jpg

LM Start	0.95	Rating **	U	Issue No.	15
LM End	0.95	Issue Type +	En	Location *	LS
Category	Earthen Levee			GPS Latitude/Longitude	
				Start	End
Item	Vegetation			38.974569 °	38.974569 °
				-121.484815 °	-121.484815 °
DWR ID	DWR_RD1001_01_s_2012_15				
Comment Code					
V6 : Landscaping					
Inspector Comment

View of the landscaping on the landside levee slope.

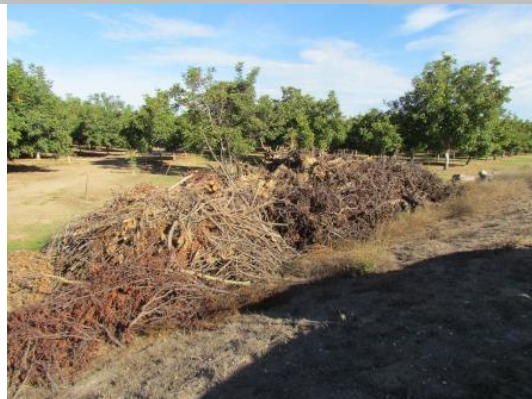
Photo 1 of 1 : FA_2016_RD1001_36_7_20160906_00005.jpg

LM Start	1.29	Rating **	M	Issue No.	7
LM End	1.29	Issue Type +	En	Location *	LS
Category	Earthen Levee			GPS Latitude/Longitude	
				Start	End
Item	Encroachments			38.972655 °	38.972655 °
				-121.490643 °	-121.490643 °
DWR ID	DWR_RD1001_01_f_2014_7				
Comment Code					
PR : Prunings					
Inspector Comment

This photo was taken from the levee crown facing east looking down the landward slope at prunings stacked up at the toe. Fall 2014.

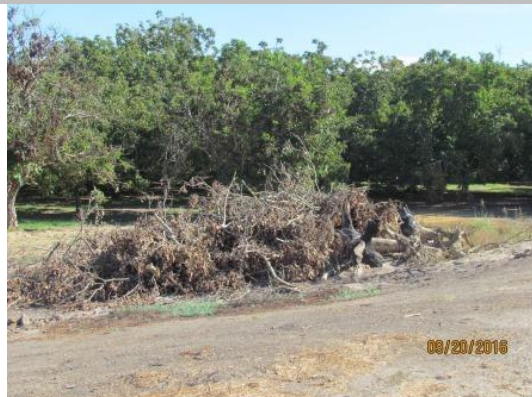
Photo 1 of 1 : FA_2016_RD1001_36_22_20160926_00026.jpg

LM Start	2.01	Rating **	M	Issue No.	22
LM End	2.01	Issue Type +	En	Location *	LS
Category	Earthen Levee			GPS Latitude/Longitude	
				Start	End
Item	Encroachments			38.971093 °	38.971093 °
				-121.502895 °	-121.502895 °
DWR ID	DWR_RD1001_01_f_2016_22				
Comment Code					
PR : Prunings					
Inspector Comment

View of pruning's on the landside toe looking upstream. Fall 2016.

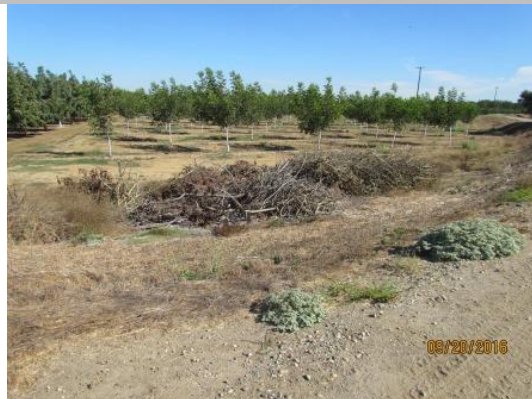
Photo 1 of 1 : FA_2016_RD1001_36_6_20160926_00025.jpg

LM Start	2.22	Rating **	M	Issue No.	6
LM End	2.22	Issue Type +	En	Location *	LS
Category	Earthen Levee			GPS Latitude/Longitude	
				Start	End
Item	Encroachments			38.969331 °	38.969331 °
				-121.505978 °	-121.505978 °
DWR ID	DWR_RD1001_01_f_2014_6				
Comment Code					
PR : Prunings					
Inspector Comment

This photo was taken of the landside looking upstream at prunings stacked up at the toe. Fall 2016.

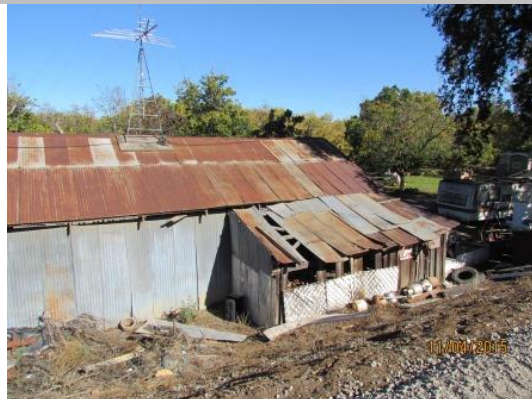
Photo 1 of 1 : FA_2016_RD1001_36_8_20160906_00006.jpg

LM Start	3.19	Rating **	U	Issue No.	8
LM End	3.19	Issue Type +	En	Location *	LS
Category	Earthen Levee			GPS Latitude/Longitude	
				Start	End
Item	Encroachments			38.965694 °	38.965694 °
				-121.522424 °	-121.522424 °
DWR ID	DWR_RD1001_01_f_2015_8				
Comment Code					
BU : Building					
Inspector Comment					
Remove debris and building to allow visibility and access to landside levee toe.

View of the shed at the landside levee toe.

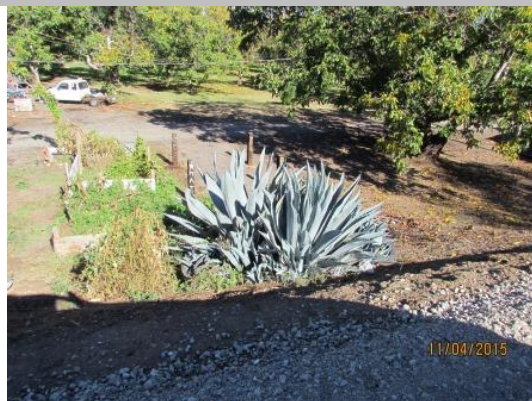
Photo 1 of 1 : FA_2016_RD1001_36_4_20160906_00001.jpg

LM Start	3.21	Rating **	U	Issue No.	4
LM End	3.21	Issue Type +	En	Location *	LS
Category	Earthen Levee			GPS Latitude/Longitude	
				Start	End
Item	Vegetation			38.965699 °	38.965699 °
				-121.522790 °	-121.522790 °
DWR ID	DWR_RD1001_01_f_2015_4				
Comment Code					
V6 : Landscaping					
Inspector Comment

View of the landscaping at the landside levee toe.

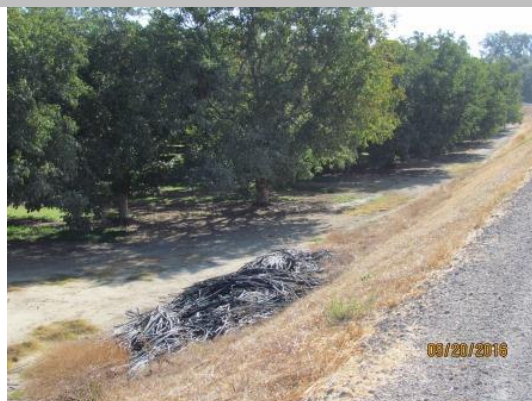
Photo 1 of 1 : FA_2016_RD1001_36_18_20160926_00020.jpg

LM Start	3.59	Rating **	M	Issue No.	18
LM End	3.59	Issue Type +	En	Location *	LS
Category	Earthen Levee			GPS Latitude/Longitude	
				Start	End
Item	Encroachments			38.965368 °	38.965368 °
				-121.529358 °	-121.529358 °
DWR ID	DWR_RD1001_01_f_2016_18				
Comment Code					
DE : Debris					
Inspector Comment					
Irrigation pipe piled on landside toe.

View of a pile of irrigation pipe on the landside levee toe looking upstream. Fall 2016.

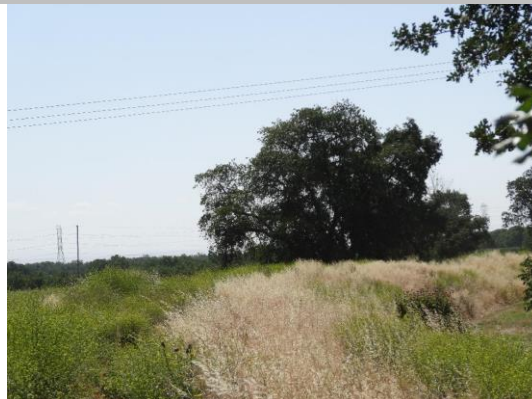
Photo 1 of 2 : UCIP_FA_2016_41673_22745.jpg

Comment Code					
Inspector Comment					
FS_ID:41673					
DS_ID:22536					
EP_NO: 5562					
Repair Type: Non-Urgent					
Crossing Status: Found					
UCIP Comments: Pipe appears abandoned and if so should be done so properly. WS pipe plugged with stopper. Seems abandoned. Only abandoned pump base found.					
FIELD_STRUCT_DESC: 6-inch steel irrigation pipe through the levee, 3.5 feet below the crown, pump (removed) and pump base on the waterward berm, siphon breaker on the landward shoulder, pipe discharges into underground irrigation system on the landward side. Power pole and meter box 10 feet from the landward toe, 1-1/2-inch flexible conduit through levee, 3.5 feet below crown (Permit No. 5562, 1966)					
FS Date: 5/23/2013

Levee Crown: dense vegetation on levee crown and sides.

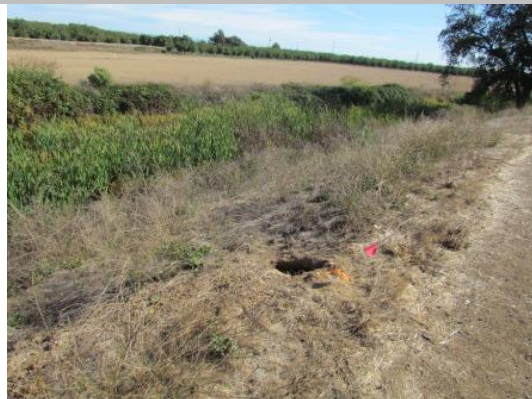
Photo 1 of 3 : FA_2016_RD1001_35_4_20160906_00001.jpg

LM Start	0.27	Rating **	A/W	Issue No.	4
LM End	0.27	Issue Type +	Ma	Location *	WS
Category	Earthen Levee			GPS Latitude/Longitude	
				Start	End
Item	Animal Control			38.974323 °	38.974323 °
				-121.476442 °	-121.476442 °
DWR ID	DWR_RD1001_02_f_2014_4				
Comment Code					
A3 : No rodents visible, but rodent burrows visible; need to backfill and compact or grout burrows.					
Inspector Comment					
There is no animal activity at this location, the existing hole near the crown needs to be repaired, Fall 2016.

This photo was taken from the levee crown facing east looking down the waterward slope at an animal burrow. Fall 2014.

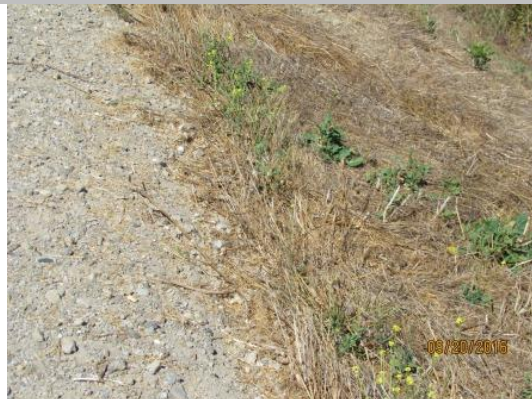
Photo 3 of 3 : FA_2016_RD1001_35_4_20160926_00021.jpg

LM Start	0.27	Rating **	A/W	Issue No.	4 (cont)	
LM End	0.27	Issue Type +	Ma	Location *	WS	
Category	Earthen Levee			GPS Latitude/Longitude		
				Start		End
Item	Animal Control			38.974323 °		38.974323 °
				-121.476442 °		-121.476442 °
DWR ID	DWR_RD1001_02_f_2014_4					
Comment Code						
A3 : No rodents visible, but rodent burrows visible; need to backfill and compact or grout burrows.						
Inspector Comment						
There is no animal activity at this location, the existing hole near the crown needs to be repaired, Fall 2016.

Although hard to see with the grass, there is still an animal hole on waterward levee slope near the crown at this location. Hole was approximately 1' in diameter and 8" deep that needs to be repaired. There is no animal activity at this location. Fall 2016.

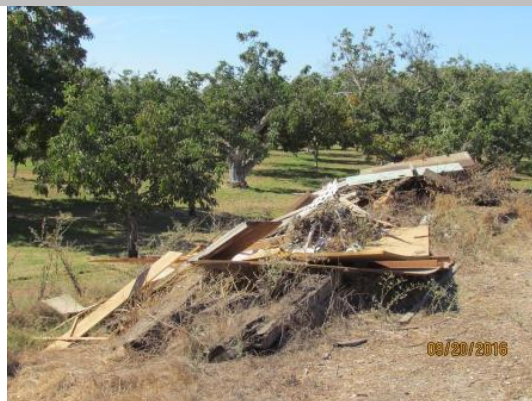
Photo 1 of 1 : FA_2016_RD1001_35_22_20160926_00025.jpg

LM Start	0.78	Rating **	M	Issue No.	22
LM End	0.78	Issue Type +	En	Location *	LS
Category	Earthen Levee			GPS Latitude/Longitude	
				Start	End
Item	Encroachments			38.973509 °	38.973509 °
				-121.485668 °	-121.485668 °
DWR ID	DWR_RD1001_02_f _ 2016_22				
Comment Code					
DE : Debris					
Inspector Comment

View of debris pile on the landside levee slope looking downstream. Fall 2016.

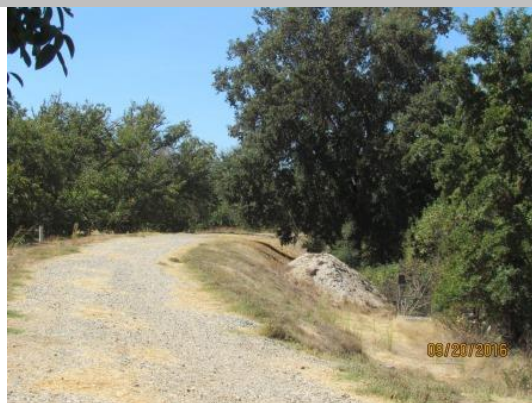
Photo 1 of 1 : FA_2016_RD1001_35_12_20160926_00027.jpg

LM Start	1.31	Rating **	M	Issue No.	12
LM End	1.31	Issue Type +	En	Location *	WS
Category	Earthen Levee			GPS Latitude/Longitude	
				Start	End
Item	Encroachments			38.969830 °	38.969830 °
				-121.493994 °	-121.493994 °
DWR ID	DWR_RD1001_02_s_2015_12				
Comment Code					
MA : Material					
Inspector Comment

View of a pile of soil on the waterside slope looking downstream. Fall 2016.

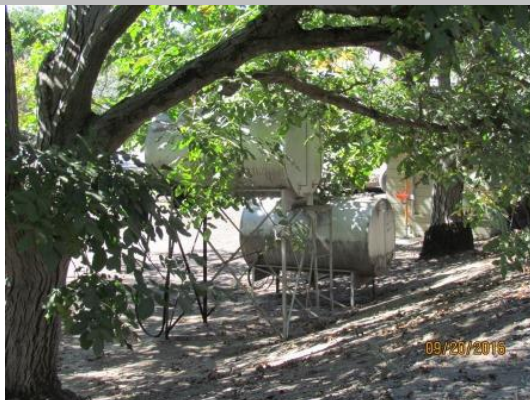
Photo 1 of 1 : FA_2016_RD1001_35_23_20160926_00028.jpg

LM Start	1.70	Rating **	M	Issue No.	23
LM End	1.70	Issue Type +	En	Location *	LS
Category	Earthen Levee			GPS Latitude/Longitude	
				Start	End
Item	Encroachments			38.970260 °	38.970260 °
				-121.501246 °	-121.501246 °
DWR ID	DWR_RD1001_02_f_2016_23				
Comment Code					
TA : Tank					
Inspector Comment					
Two tanks that are at the landside levee toe and should be moved from the easement.

View of two tanks that are at the landside levee toe. Fall 2016.

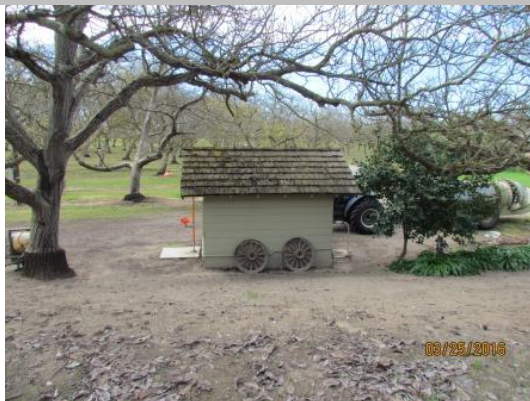
Photo 1 of 1 : FA_2016_RD1001_35_18_20160906_00009.jpg

LM Start	1.71	Rating **	M	Issue No.	18
LM End	1.71	Issue Type +	En	Location *	LS
Category	Earthen Levee			GPS Latitude/Longitude	
				Start	End
Item	Encroachments			38.970264 °	38.970264 °
				-121.501343 °	-121.501343 °
DWR ID	DWR_RD1001_02_s_2016_18				
Comment Code					
BU : Building					
Inspector Comment

Shed at landside toe.

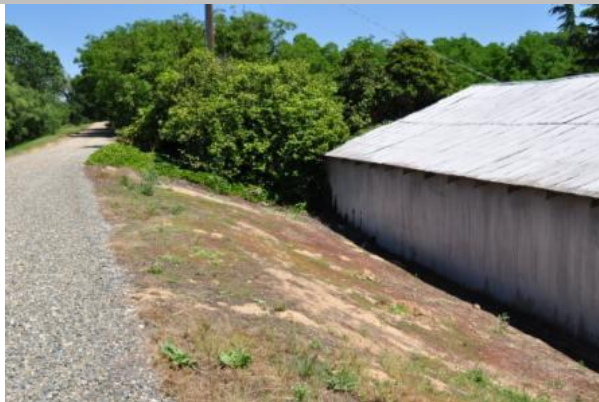
Photo 1 of 1 : FA_2016_RD1001_35_10_20160906_00005.jpg

LM Start	1.74	Rating **	U	Issue No.	10
LM End	1.74	Issue Type +	En	Location *	LS
Category	Earthen Levee			GPS Latitude/Longitude	
				Start	End
Item	Vegetation			38.970353 °	38.970353 °
				-121.501935 °	-121.501935 °
DWR ID	DWR_RD1001_02_s_2012_10				
Comment Code					
V6 : Landscaping					
Inspector Comment

RD 1001 Unit 2 - L/S -Landscaping - Trees

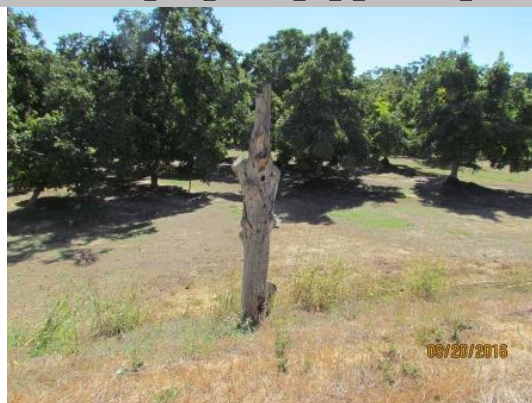
Photo 1 of 1 : FA_2016_RD1001_35_6_20160926_00029.jpg

LM Start	1.88	Rating **	N	Issue No.	6
LM End	1.88	Issue Type +	Ma	Location *	LS
Category	Earthen Levee			GPS Latitude/Longitude	
				Start	End
Item	Trim / Thin Trees			38.969489 °	38.969489 °
				-121.504155 °	-121.504155 °
DWR ID	DWR_RD1001_02_f_2015_6				
Comment Code					
T5 : Tree stumps.					
Inspector Comment					
Large stump at the landside levee toe should be removed.

View of large stump at the landside levee toe. Fall 2016.

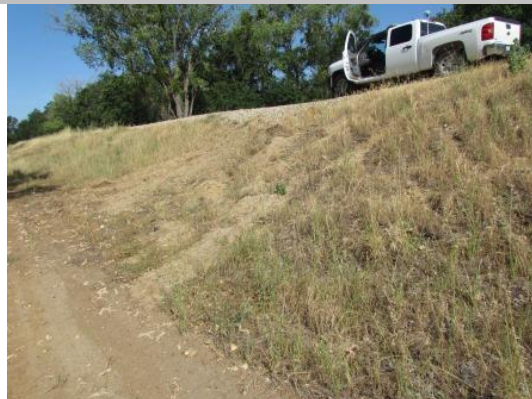
Photo 1 of 1 : FA_2016_RD1001_37_23_20160906_00014.jpg

LM Start	0.14	Rating **	M	Issue No.	23
LM End	0.14	Issue Type +	Ma	Location *	LS
Category	Earthen Levee			GPS Latitude/Longitude	
				Start	End
Item	Slope Stability			39.006351 °	39.006351 °
				-121.377313 °	-121.377313 °
DWR ID	DWR_RD1001_03_s_2015_23				
Comment Code					
S3 : Repair the levee slope damaged by vehicle traffic and prevent access where possible.					
Inspector Comment					
Rutting caused by vehicles driving up the landward levee slope.

View of the rutting on the landside of the levee from the toe facing downstream.

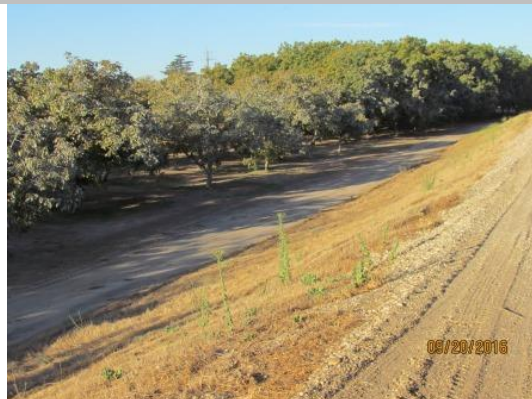
Photo 2 of 2 : FA_2016_RD1001_37_30_20160926_00043.jpg

LM Start	2.28	Rating **	A/W	Issue No.	30 (cont)	
LM End	2.28	Issue Type +	Ma	Location *	LS	
Category	Earthen Levee			GPS Latitude/Longitude		
				Start	End	
Item	Slope Stability			38.996302 °	38.996302 °	
				-121.412285 °	-121.412285 °	
DWR ID	DWR_RD1001_03_s _ 2013_30					
Comment Code						
S3 : Repair the levee slope damaged by vehicle traffic and prevent access where possible.						
Inspector Comment						
Damage to landside slope has been repaired. Continue to monitor area.

Damage to landside slope has been repaired. Fall 2016.

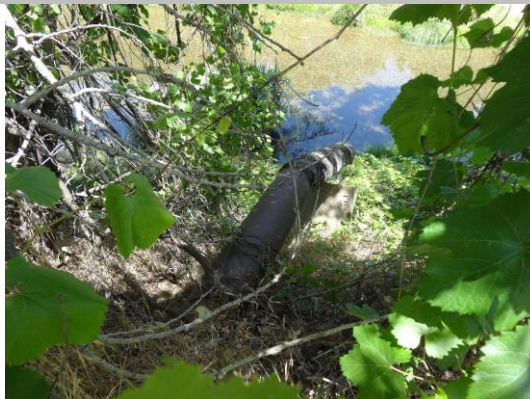
Photo 1 of 2 : UCIP_FA_2016_41722_23338.jpg

WS- only a steel pipe found on riverbank.

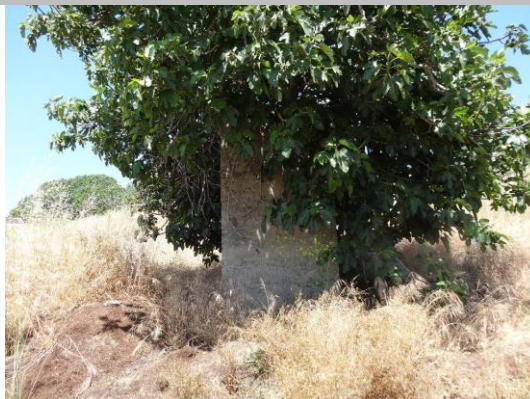
Photo 2 of 2 : UCIP_FA_2016_41722_23337.jpg

LS- a big tree inside concrete standpipe.

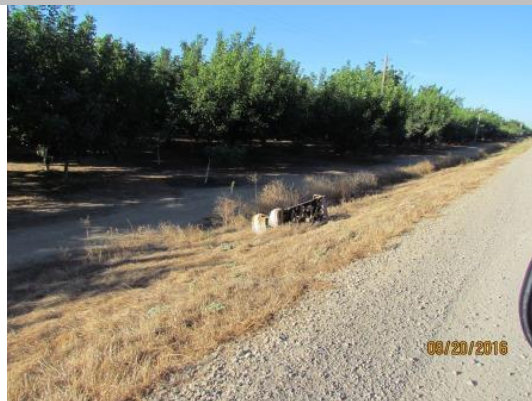
Photo 1 of 1 : FA_2016_RD1001_37_42_20160926_00048.jpg

LM Start	2.96	Rating **	M	Issue No.	42
LM End	2.96	Issue Type +	Ma	Location *	LS
Category	Earthen Levee			GPS Latitude/Longitude	
				Start	End
Item	Encroachments			38.994157°	38.994157°
				-121.424520°	-121.424520°
DWR ID	DWR_RD1001_03_f_2013_42				
Comment Code					
DE : Debris					
Inspector Comment					
Remove couch on levee slope.

View of a couch on the landside levee slope looking downstream. Fall 2016.

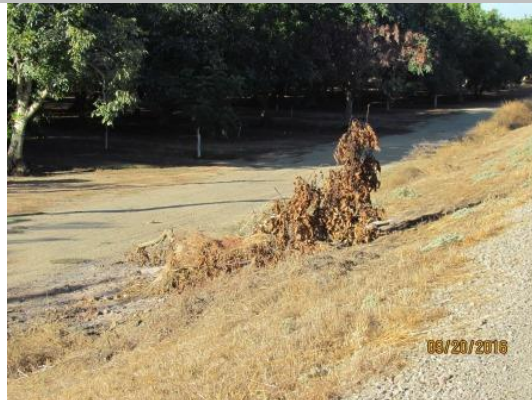
Photo 1 of 1 : FA_2016_RD1001_37_19_20160926_00049.jpg

LM Start	3.13	Rating **	M	Issue No.	19
LM End	3.13	Issue Type +	En	Location *	LS
Category	Earthen Levee			GPS Latitude/Longitude	
				Start	End
Item	Encroachments			38.993446°	38.993446°
				-121.427490°	-121.427490°
DWR ID	DWR_RD1001_03_f_2016_19				
Comment Code					
PR : Prunings					
Inspector Comment

View of prunings on landside levee slope looking downstream. Fall 2016.

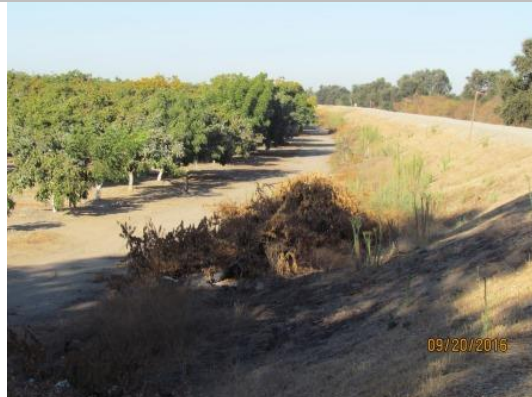
Photo 2 of 2 : FA_2016_RD1001_37_9_20160926_00052.jpg

LM Start	4.46	Rating **	M	Issue No.	9 (cont)	
LM End	4.46	Issue Type +	En	Location *	LS	
Category	Earthen Levee			GPS Latitude/Longitude		
				Start		End
Item	Encroachments			38.991867 °		38.991867 °
				-121.451743 °		-121.451743 °
DWR ID	DWR_RD1001_03_s_2013_9					
Comment Code						
MA : Material						
Inspector Comment						
Drip irrigation tubing has been removed that was within the easement of the landside levee. There is a new pile of pruning's at the toe.

Drip irrigation tubing has been removed that was within the easement of the landside levee. There is a new pile of pruning's at the toe. Fall 2016

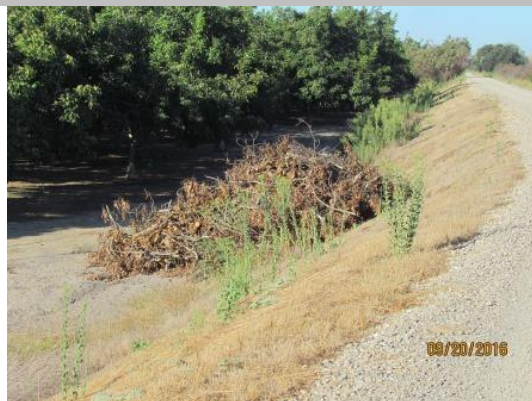
Photo 1 of 1 : FA_2016_RD1001_37_12_20160926_00054.jpg

LM Start	4.69	Rating **	M	Issue No.	12
LM End	4.69	Issue Type +	En	Location *	LS
Category	Earthen Levee			GPS Latitude/Longitude	
				Start	End
Item	Encroachments			38.991424 °	38.991424 °
				-121.455839 °	-121.455839 °
DWR ID	DWR_RD1001_03_s_2012_12				
Comment Code					
PR : Prunings					
Inspector Comment

View of pruning's on the landside slope. Fall 2016.

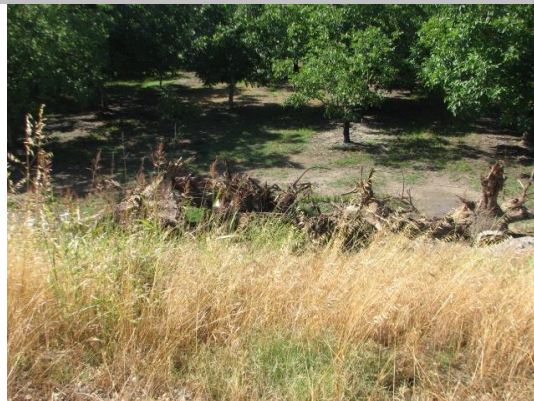
Photo 1 of 1 : FA_2016_RD1001_37_39_20160906_00023.jpg

LM Start	6.85	Rating **	M	Issue No.	39
LM End	6.85	Issue Type +	En	Location *	LS
Category	Earthen Levee			GPS Latitude/Longitude	
				Start	End
Item	Encroachments			38.983328°	38.983328°
				-121.494400°	-121.494400°
DWR ID	DWR_RD1001_03_s_2013_39				
Comment Code					
PR : Prunings					
Inspector Comment

Walnut stumps within the easement of the levee.

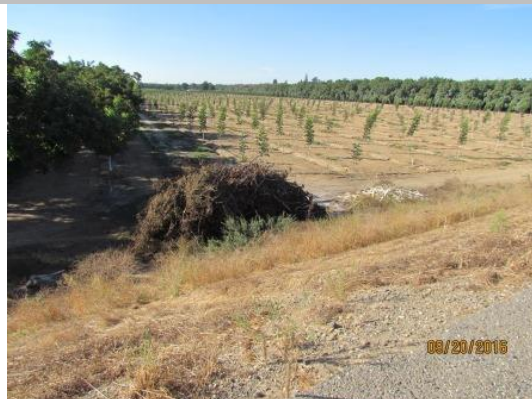
Photo 1 of 1 : FA_2016_RD1001_37_46_20160926_00059.jpg

LM Start	7.07	Rating **	M	Issue No.	46
LM End	7.07	Issue Type +	En	Location *	LS
Category	Earthen Levee			GPS Latitude/Longitude	
				Start	End
Item	Encroachments			38.982850 °	38.982850 °
				-121.498516 °	-121.498516 °
DWR ID	DWR_RD1001_03_s_2016_46				
Comment Code					
PR : Prunings					
Inspector Comment

Prunings at landside toe. Fall 2016.

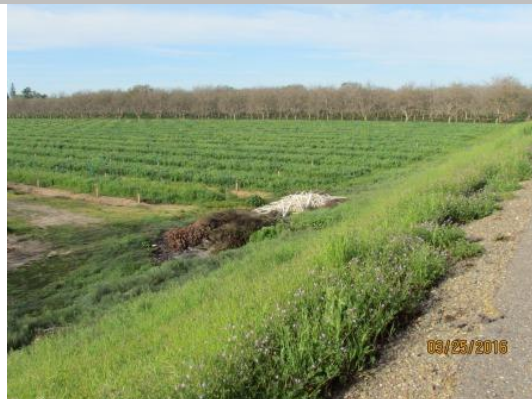
Photo 1 of 1 : FA_2016_RD1001_37_45_20160906_00024.jpg

LM Start	7.08	Rating **	M	Issue No.	45
LM End	7.08	Issue Type +	En	Location *	WS
Category	Earthen Levee			GPS Latitude/Longitude	
				Start	End
Item	Encroachments			38.982844 °	38.982844 °
				-121.498569 °	-121.498569 °
DWR ID	DWR_RD1001_03_s_2015_45				
Comment Code					
DE : Debris					
Inspector Comment

PVC pipe and debris at landside toe.

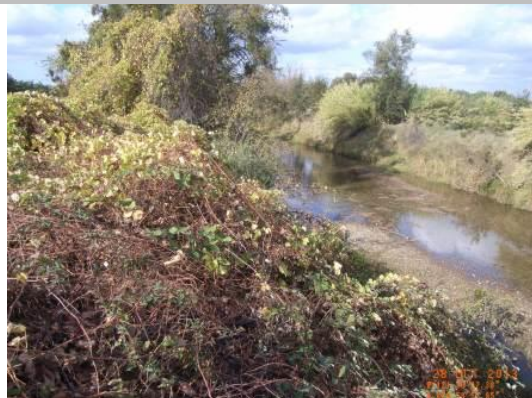
Photo 1 of 1 : FA_2016_RD1001_37_17_20160906_00012.jpg

LM Start	7.22	Rating **	M	Issue No.	17
LM End	7.31	Issue Type +	Ma	Location *	WS
Category	Supplemental			GPS Latitude/Longitude	
				Start	End
Item	2015 USACE Erosion Survey, DRAFT			38.982737 °	38.982572 °
				-121.501144 °	-121.502797 °
DWR ID	DWR_RD1001_03_s_2016_17				
Comment Code					
Inspector Comment					
2008 - Sandy/silty banks with rotational slab failures creating near vertical bank with pop-outs due to tree failures. Narrow berm. 2015: Last observed in 2013. [2015 Site ID: BER_5-7_L]

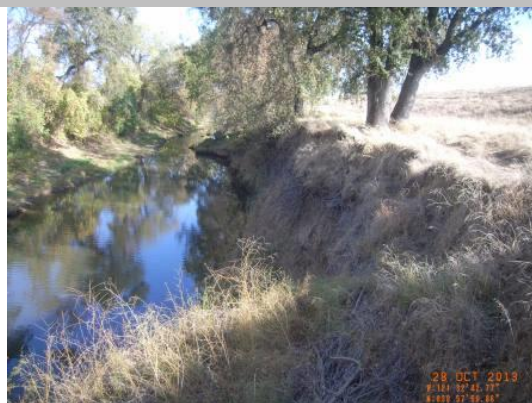
Photo 1 of 1 : FA_2016_RD1001_37_10_20160906_00011.jpg

LM Start	10.36	Rating **	M	Issue No.	10
LM End	10.40	Issue Type +	Ma	Location *	WS
Category	Supplemental			GPS Latitude/Longitude	
				Start	End
Item	2015 USACE Erosion Survey, DRAFT			38.964583 °	38.964010 °
				-121.544967 °	-121.545228 °
DWR ID	DWR_RD1001_03_s_2016_10				
Comment Code					
Inspector Comment					
2011 - Large section of bank has slumped off. RD has flagged and appears to be watching. 2012 - Slopes slightly steeper. 2013 - Minor new erosion observed. 2015: Last observed in 2013. [2015 Site ID: BER_2-5_L]

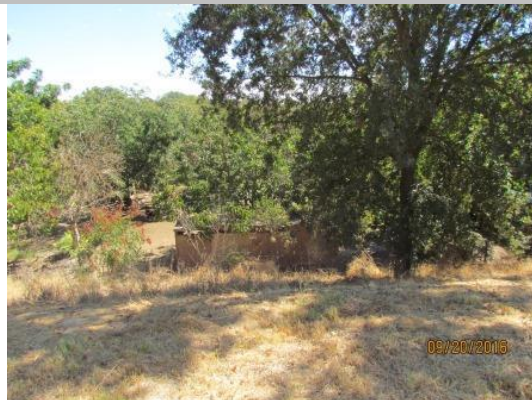
Photo 1 of 1 : FA_2016_RD1001_37_11_20160926_00062.jpg

LM Start	10.49	Rating **	M	Issue No.	11
LM End	10.49	Issue Type +	En	Location *	LS
Category	Earthen Levee			GPS Latitude/Longitude	
				Start	End
Item	Encroachments			38.962770 °	38.962770 °
				-121.545741 °	-121.545741 °
DWR ID	DWR_RD1001_03_f_2015_11				
Comment Code					
BU : Building					
Inspector Comment

View of building at the landside toe. Fall 2016.

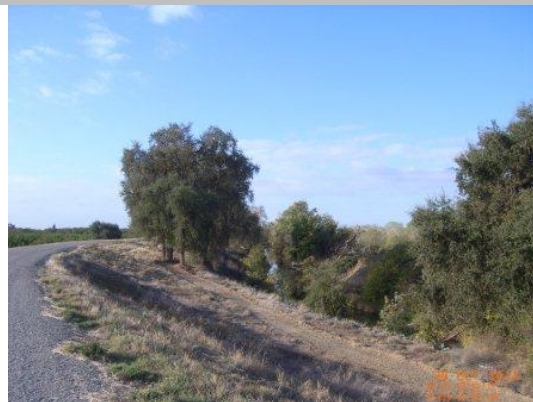
Photo 1 of 1 : FA_2016_RD1001_37_1_20160906_00001.jpg

LM Start	11.08	Rating **	M	Issue No.	1
LM End	11.16	Issue Type +	Ma	Location *	WS
Category	Supplemental			GPS Latitude/Longitude	
				Start	End
Item	2015 USACE Erosion Survey, DRAFT			38.955070 °	38.954227 °
				-121.549528 °	-121.550592 °
DWR ID	DWR_RD1001_03_s_2016_1				
Comment Code					
Inspector Comment					
2011 - Large slumped sections of bank. 2012 - Slopes slightly steeper. 2015: Last observed in 2013. [2015 Site ID: BER_1-9_L]

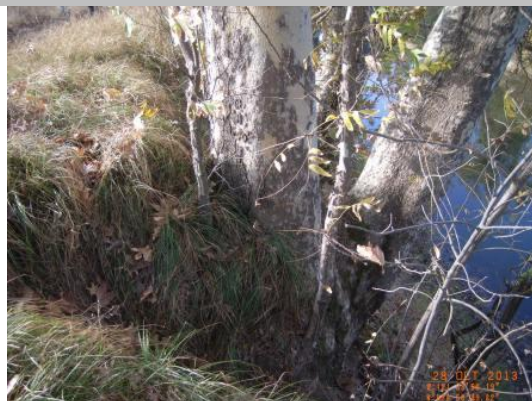
Photo 1 of 1 : FA_2016_RD1001_37_4_20160906_00005.jpg

LM Start	12.07	Rating **	M	Issue No.	4
LM End	12.16	Issue Type +	Ma	Location *	WS
Category	Supplemental			GPS Latitude/Longitude	
				Start	End
Item	2015 USACE Erosion Survey, DRAFT			38.947591 °	38.946477 °
				-121.563390 °	-121.564094 °
DWR ID	DWR_RD1001_03_s_2016_4				
Comment Code					
Inspector Comment					
2006 - Multiple rotational failures in the berm. Erosion is into the levee toe and lower slope. Tension cracks extensive at top of bank. Cohesive toe creates a bench on which failures occur. 2007 - Still steep bank with some berm with pistol-butted reeds. 2012 - Site extended upstream due to additional slumping. Slopes slightly steeper. 2015: Last observed in 2013. [2015 Site ID: BER_0-8_L]

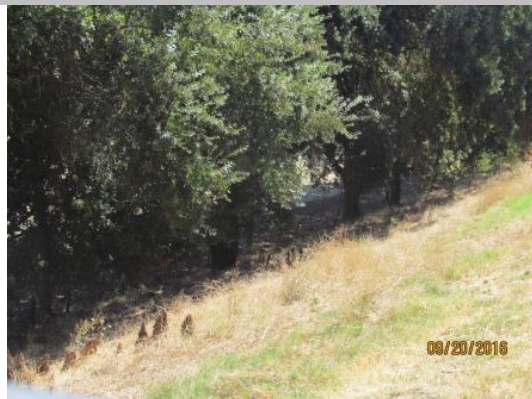
Photo 1 of 1 : FA_2016_RD1001_38_39_20160926_00061.jpg

LM Start	2.05	Rating **	A/W	Issue No.	39
LM End	2.05	Issue Type +	Ma	Location *	LS
Category	Earthen Levee			GPS Latitude/Longitude	
				Start	End
Item	Trim / Thin Trees			38.912664 °	38.912664 °
				-121.572928 °	-121.572928 °
DWR ID	DWR_RD1001_04_s_2015_39				
Comment Code					
T2 : Thin trees to allow visibility of the ground and room to flood fight.					
Inspector Comment

Tree limbs have been trimmed to allow visibility and access on the landside looking downstream. Fall 2016.

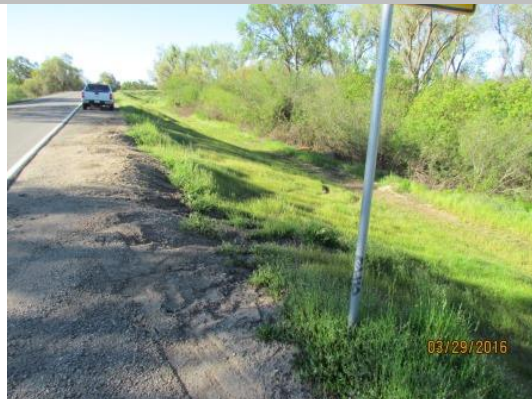
Photo 1 of 2 : FA_2016_RD1001_38_78_20160906_00028.jpg

LM Start	5.22	Rating **	M	Issue No.	78
LM End	5.22	Issue Type +	Ma	Location *	WS
Category	Earthen Levee			GPS Latitude/Longitude	
				Start	End
Item	Slope Stability			38.881768 °	38.881768 °
				-121.611302 °	-121.611302 °
DWR ID	DWR_RD1001_04_s_2016_78				
Comment Code					
S3 : Repair the levee slope damaged by vehicle traffic and prevent access where possible.					
Inspector Comment

Ruts on waterside slope due to vehicles. Spring 2016.

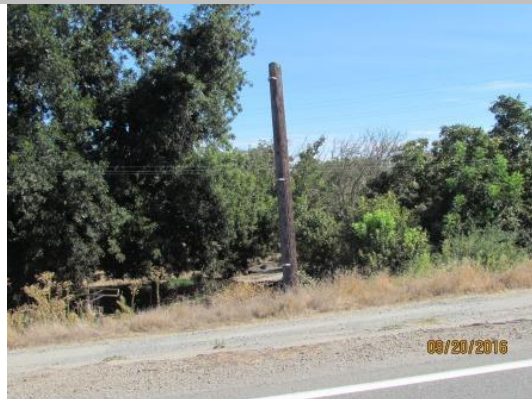
Photo 1 of 1 : FA_2016_RD1001_38_27_20160926_00070.jpg

LM Start	5.71	Rating **	M	Issue No.	27
LM End	5.71	Issue Type +	En	Location *	LS
Category	Earthen Levee			GPS Latitude/Longitude	
				Start	End
Item	Encroachments			38.874984 °	38.874984 °
				-121.614242 °	-121.614242 °
DWR ID	DWR_RD1001_04_s_2015_27				
Comment Code					
PO : Pole					
Inspector Comment

View of pole on landside, no lines connected to it. Fall 2016.

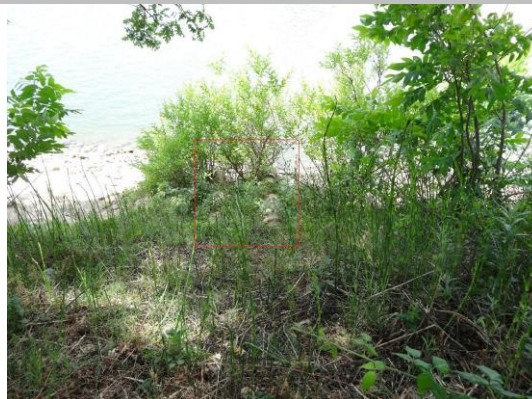
Photo 2 of 2 : UCIP_FA_2016_14604_24106.jpg

Item	DWR UCIP Field Study			38.874113 °		38.874113 °
				-121.614846 °		-121.614846 °
DWR ID						
Comment Code						
Inspector Comment						
FS_ID:14604						
DS_ID:22573						
EP_NO: 10389						
Repair Type: Non-Urgent						
Crossing Status: Found						
UCIP Comments: - water leakage causes erosion on LS slope.- may be pressure breaker valve not closed properly on LS.- a 36-inch concrete standpipe at the landward toe not found.						
FIELD_STRUCT_DESC: 12-inch irrigation pipe through the levee, 10.0 feet below the crown, slant pump on the bank, siphon breaker in a 24-inch corrugated metal pipe riser on the landward slope, pipe discharges into a 36-inch concrete standpipe at the landward toe, pipe installed by the U.S.C.E. in 1963, switch panel and service pole at the landward toe (Permit No. 10389, 1974)						
FS Date: 5/16/2013

WS- inlet pipe on the river bank.

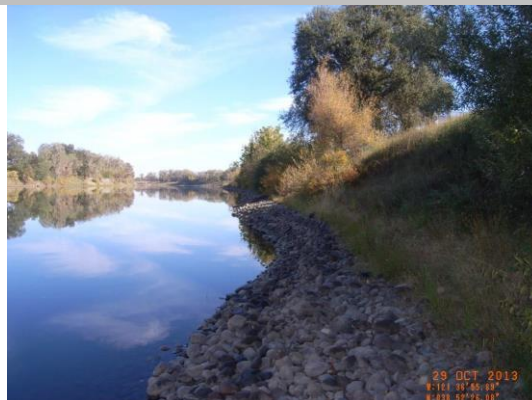
Photo 1 of 1 : FA_2016_RD1001_38_2_20160906_00002.jpg

LM Start	5.80	Rating **	M	Issue No.	2
LM End	5.93	Issue Type +	Ma	Location *	WS
Category	Supplemental			GPS Latitude/Longitude	
				Start	End
Item	2015 USACE Erosion Survey, DRAFT			38.874113 °	38.872373 °
				-121.615380 °	-121.616504 °
DWR ID	DWR_RD1001_04_s_2016_2				
Comment Code					
Inspector Comment					
2011 - Erosion pockets from tree popouts. Sections of the lower bank have slumped off. 2013 - Scallops from tree popouts no longer visible on site. Minor new erosion at the middle of the bank. 2015: Fresh erosion from human use. [2015 Site ID: FHR_6-6_L]

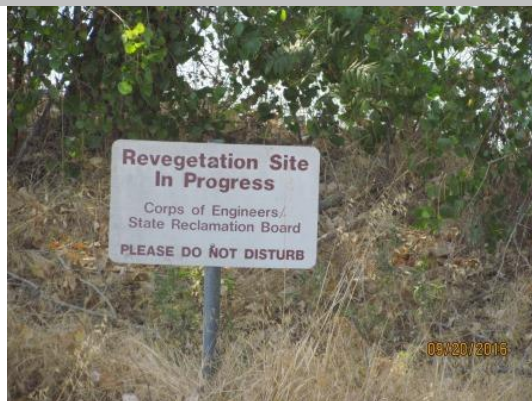
Photo 1 of 1 : FA_2016_RD1001_38_40_20160926_00071.jpg

LM Start	5.96	Rating **	A/W	Issue No.	40
LM End	5.96	Issue Type +	Ob	Location *	WS
Category	Earthen Levee			GPS Latitude/Longitude	
				Start	End
Item	Vegetation			38.871770 °	38.871770 °
				-121.616304 °	-121.616304 °
DWR ID	DWR_RD1001_04_s_2015_40				
Comment Code					
V8 : Environmental Requirements.					
Inspector Comment

Vegetation was introduced to this location.

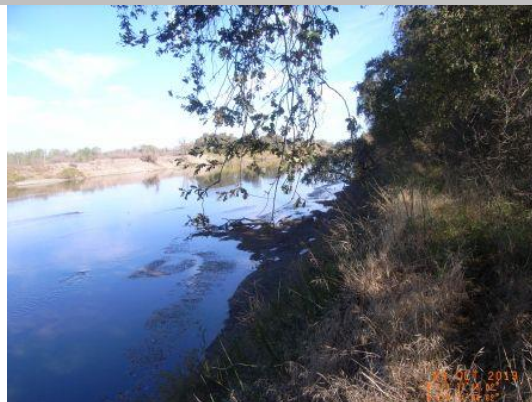
Photo 1 of 1 : FA_2016_RD1001_38_5_20160906_00005.jpg

LM Start	6.42	Rating **	M	Issue No.	5
LM End	6.51	Issue Type +	Ma	Location *	WS
Category	Supplemental			GPS Latitude/Longitude	
				Start	End
Item	2015 USACE Erosion Survey, DRAFT			38.865875 °	38.864706 °
				-121.619983 °	-121.620813 °
DWR ID	DWR_RD1001_04_s_2016_5				
Comment Code					
Inspector Comment					
2011 - Tall slumping sections. Scour around trees has exposed most of the roots. 2015: Recent large slope failure observed. [2015 Site ID: FHR_6-0_L]

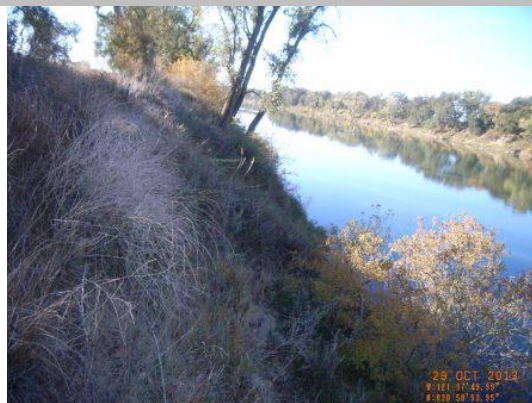
Photo 1 of 1 : FA_2016_RD1001_38_8_20160906_00008.jpg

LM Start	7.47	Rating **	M	Issue No.	8
LM End	7.79	Issue Type +	Ma	Location *	WS
Category	Supplemental			GPS Latitude/Longitude	
				Start	End
Item	2015 USACE Erosion Survey, DRAFT			38.852394 °	38.848004 °
				-121.629231 °	-121.630873 °
DWR ID	DWR_RD1001_04_s_2016_8				
Comment Code					
Inspector Comment					
2000 - Steep bank off berm with some slumps and fallen trees, continued erosion. 2002 - Site lengthened upstream and downstream due to vertical bank along most of the reach. 2010 - Site extended upstream. 2011 - Minimal new erosion. 2012 - Site extended on the upstream end, new tree pop-out, and bank erosion continues to worsen. 2013 - Minor new erosion at the toe and top of bank. 2015: No observed changes. [2015 Site ID: FHR_5-0_L]

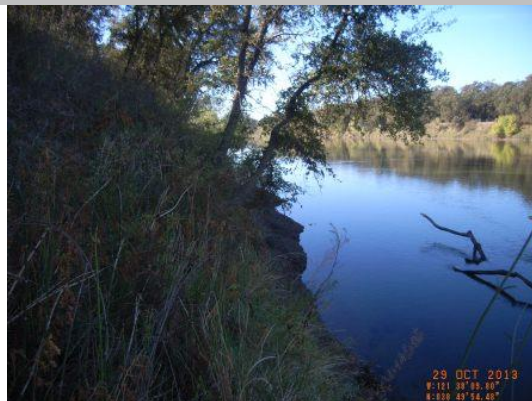
Photo 1 of 1 : FA_2016_RD1001_38_7_20160906_00007.jpg

LM Start	8.57	Rating **	M	Issue No.	7
LM End	8.97	Issue Type +	Ma	Location *	WS
Category	Supplemental			GPS Latitude/Longitude	
				Start	End
Item	2015 USACE Erosion Survey, DRAFT			38.836966 °	38.831498 °
				-121.634128 °	-121.636371 °
DWR ID	DWR_RD1001_04_s_2016_7				
Comment Code					
Inspector Comment					
2006 - Sandy, silty bank with intermittent pockets of erosion. Rotational failure and tree pop outs are most of the problem. Some upper slope fluvial erosion. 2010 - Site extended upstream. The lower Feather may benefit from a regional repair. 2011 - Site combined with 3.6. Minimal new erosion. 2013 - New erosion observed at bank toe. Trees on site now have exposed roots. 2015: No observed changes. [2015 Site ID: FHR 3-8 L]

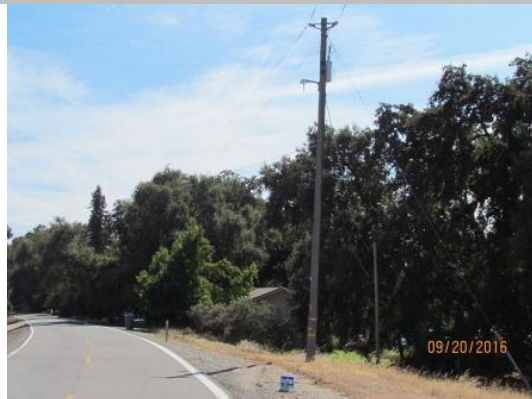
Photo 1 of 1 : FA_2016_RD1001_38_80_20160926_00076.jpg

LM Start	9.52	Rating **	M	Issue No.	80
LM End	9.52	Issue Type +	En	Location *	WS
Category	Earthen Levee			GPS Latitude/Longitude	
				Start	End
Item	Encroachments			38.823911 °	38.823911 °
				-121.639869 °	-121.639869 °
DWR ID	DWR_RD1001_04_s_2016_80				
Comment Code					
PO : Pole					
Inspector Comment

View of pole on waterside crown. Fall 2016.

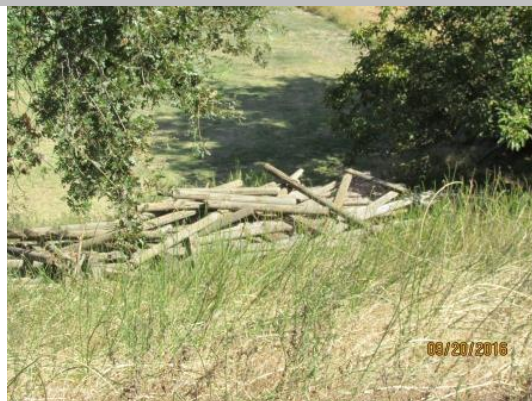
Photo 1 of 1 : FA_2016_RD1001_38_82_20160926_00077.jpg

LM Start	9.58	Rating **	M	Issue No.	82
LM End	9.58	Issue Type +	En	Location *	LS
Category	Earthen Levee			GPS Latitude/Longitude	
				Start	End
Item	Encroachments			38.823053 °	38.823053 °
				-121.639911 °	-121.639911 °
DWR ID	DWR_RD1001_04_s_2016_82				
Comment Code					
DE : Debris					
Inspector Comment					
Old fence post pile at landside levee toe.

View of a pile of fence post at the landside levee toe. Fall 2016.

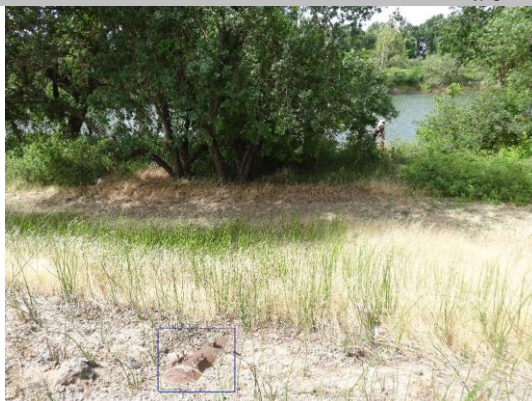
Photo 1 of 2 : UCIP_FA_2016_14627_24134.jpg

LM Start	9.92	Rating **	M	Issue No.	152
LM End	9.92	Issue Type +	En	Location *	WS
Category	Supplemental			GPS Latitude/Longitude	
				Start	End
Item	DWR UCIP Field Study			38.818341 °	38.818341 °
				-121.638890 °	-121.638890 °
DWR ID					
Comment Code					
Inspector Comment					
FS_ID:14627					
DS_ID:22578					
EP_NO: 3297					
Repair Type: Non-Urgent					
Crossing Status: Found					
UCIP Comments: - needs properly abandoned.- dismantled standpipe found on LS levee slope					
FIELD_STRUCT_DESC: 12-inch steel pipe through the levee, 3.0 feet below the crown, slant pump mounted on a steel structure on the bank, siphon breaker on the landward shoulder, pipe discharges into a 24-inch concrete standpipe at the landward toe (Permit No. 3297, 1960).					
FS Date: 5/16/2013

WS- exposed pipe on levee slope and pump station in river bank.

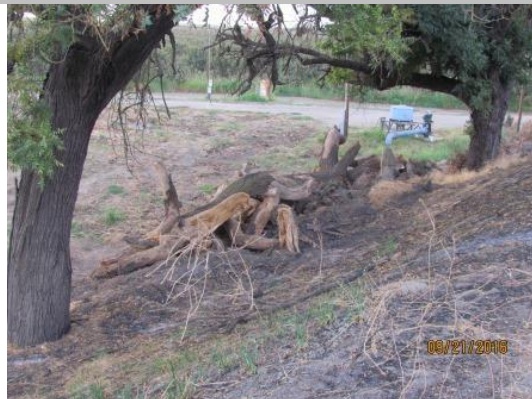
Photo 1 of 1 : FA_2016_RD1001_38_66_20160927_00083.jpg

LM Start	9.97	Rating **	M	Issue No.	66
LM End	9.97	Issue Type +	En	Location *	LS
Category	Earthen Levee			GPS Latitude/Longitude	
				Start	End
Item	Encroachments			38.817659 °	38.817659 °
				-121.638404 °	-121.638404 °
DWR ID	DWR_RD1001_04_f_2016_66				
Comment Code					
TR : Tree or limb					
Inspector Comment					
Downed tree pushed up to levee toe.

View of large tree pushed up to the landside levee toe. Fall 2016.

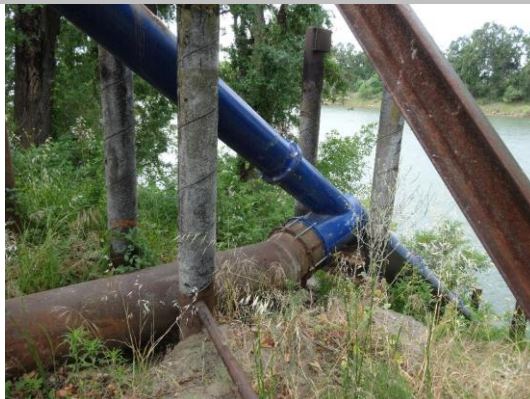
Photo 2 of 2 : UCIP_FA_2016_41723_23976.jpg

LM Start	10.14	Rating **	M	Issue No.	158 (cont)	
LM End	10.14	Issue Type +	En	Location *	LS	
Category	Supplemental			GPS Latitude/Longitude		
				Start		End
Item	DWR UCIP Field Study			38.815530 °		38.815530 °
				-121.636918 °		-121.636918 °
DWR ID						
Comment Code						
Inspector Comment						
FS_ID:41723 DS_ID:22572 EP_NO: 1881 Repair Type: Non-Urgent Crossing Status: Found UCIP Comments: - burried slide gate found on WS slope.- concrete box at the landward toe not found. FIELD_STRUCT_DESC: 18-inch steel pipe through the levee, 5.0 feet below the crown, slant pump mounted on a pile structure on the bank, gate valve on the waterward slope, siphon breaker on the landward shoulder, pipe discharges into a concrete box at the landward toe (Permit No. 1881, 1954). FS Date: 5/16/2013

WS- main steel pipe on levee surface (without paint).

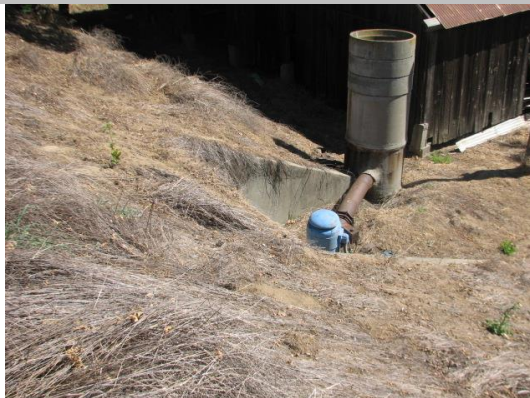
Photo 1 of 1 : FA_2016_RD1001_38_30_20160906_00017.jpg

LM Start	10.60	Rating **	M	Issue No.	30
LM End	10.60	Issue Type +	En	Location *	LS
Category	Earthen Levee			GPS Latitude/Longitude	
				Start	End
Item	Encroachments			38.809257 °	38.809257 °
				-121.633909 °	-121.633909 °
DWR ID	DWR_RD1001_04_s_2013_30				
Comment Code					
RW : Retaining Wall					
Inspector Comment

A retaining wall is within the profile of the slope. Spring 2013

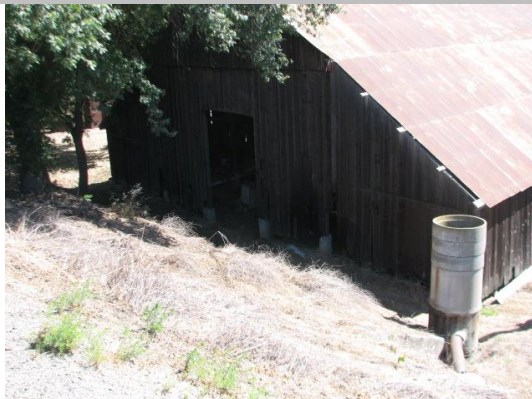
Photo 1 of 1 : FA_2016_RD1001_38_29_20160906_00016.jpg

LM Start	10.60	Rating **	M	Issue No.	29
LM End	10.60	Issue Type +	En	Location *	LS
Category	Earthen Levee			GPS Latitude/Longitude	
				Start	End
Item	Encroachments			38.809256 °	38.809256 °
				-121.633908 °	-121.633908 °
DWR ID	DWR_RD1001_04_s _ 2013_29				
Comment Code					
BU : Building					
Inspector Comment

The building is within the easement of the levee. Spring 2013

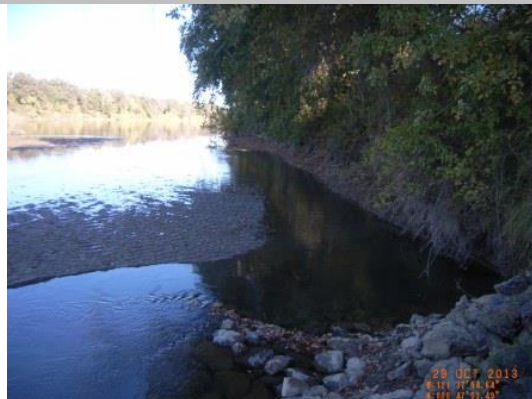
Photo 1 of 1 : FA_2016_RD1001_38_6_20160906_00006.jpg

LM Start	11.18	Rating **	M	Issue No.	6
LM End	11.37	Issue Type +	Ma	Location *	WS
Category	Supplemental			GPS Latitude/Longitude	
				Start	End
Item	2015 USACE Erosion Survey, DRAFT			38.800920 °	38.798165 °
				-121.633050 °	-121.631939 °
DWR ID	DWR_RD1001_04_s_2016_6				
Comment Code					
Inspector Comment					
2000 - Site is relatively stable except for some toe erosion at the upstream end, recommend monitoring the upstream end. 2004 - Some new block failures (10ft deep) at the toe of the upstream end. 2007 - Some minor new slumping at the waterline. 2013 - Minor new erosion along the bank toe. 2015: No observed changes. [2015 Site ID: FHR_1-0_L]

USACE 2013 Photo #1

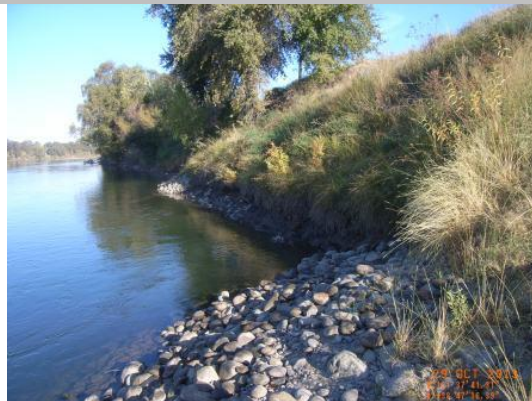
Photo 1 of 1 : FA_2016_RD1001_38_1_20160906_00001.jpg

LM Start	11.59	Rating **	M	Issue No.	1
LM End	11.75	Issue Type +	Ma	Location *	WS
Category	Supplemental			GPS Latitude/Longitude	
				Start	End
Item	2015 USACE Erosion Survey, DRAFT			38.795455 °	38.793394 °
				-121.629903 °	-121.628156 °
DWR ID	DWR_RD1001_04_s_2016_1				
Comment Code					
Inspector Comment					
1997- Deposits over top of cobble on the upper slope. 2000 - Old cobble site in poor shape; some toe retreat, but little change; steep bank. 2010 - Site extended upstream due to new toe erosion. 2012 - Minor new erosion at toe, new slumping, animals holes and cracks observed. 2015: No observed changes. [2015 Site ID: FHR_0-6_L]

USACE 2013 Photo #1

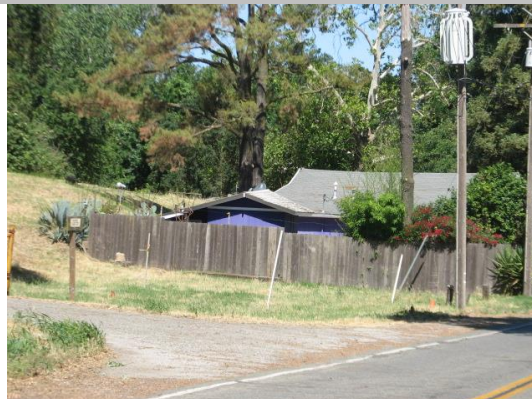
Photo 2 of 2 : FA_2016_RD1001_38_25_20160906_00014.jpg

LM Start	12.48	Rating **	U	Issue No.	25 (cont)	
LM End	12.48	Issue Type +	En	Location *	LS	
Category	Earthen Levee			GPS Latitude/Longitude		
				Start		End
Item	Encroachments			38.786073 °		38.786073 °
				-121.618522 °		-121.618522 °
DWR ID	DWR_RD1001_04_s_2012_25					
Comment Code						
BU : Building						
Inspector Comment

A building is at the toe of the levee. Spring 2013

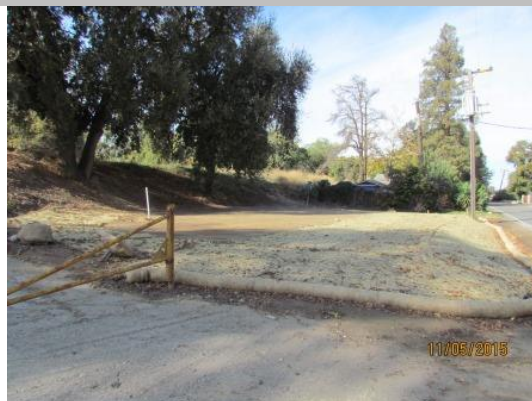
Photo 1 of 1 : FA_2016_RD1001_38_57_20160906_00024.jpg

LM Start	12.51	Rating **	A/W	Issue No.	57
LM End	12.51	Issue Type +	En	Location *	LS
Category	Earthen Levee			GPS Latitude/Longitude	
				Start	End
Item	Encroachments			38.785850 °	38.785850 °
				-121.618071 °	-121.618071 °
DWR ID	DWR_RD1001_04_f_2015_57				
Comment Code					
BU : Building					
Inspector Comment					
New construction pending.

View of the house pad at the landside levee toe.

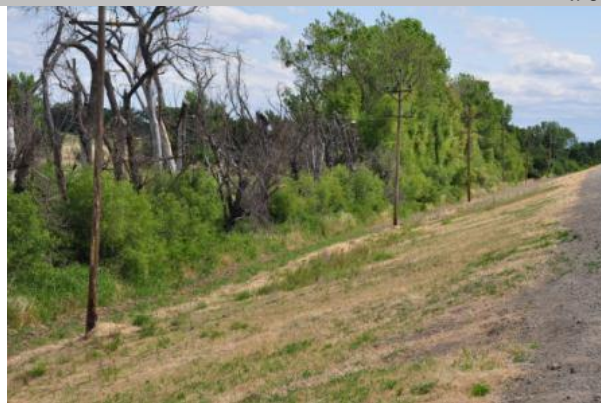
Photo 1 of 2 : FA_2016_RD1001_39_5_20160906_00001.jpg

LM Start	0.19	Rating **	M	Issue No.	5
LM End	0.85	Issue Type +	En	Location *	LS
Category	Earthen Levee			GPS Latitude/Longitude	
				Start	End
Item	Encroachments			38.783758 °	38.791058 °
				-121.604189 °	-121.596562 °
DWR ID	DWR_RD1001_05_s_2012_5				
Comment Code					
PO : Pole					
Inspector Comment

RD 1001 Unit 5 - L/S Levee Toe - Poles

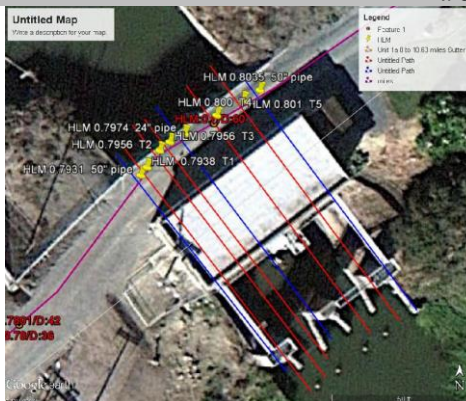
Photo 1 of 2 : UCIP_FA_2016_14393_23697.jpg

Comment Code						
Inspector Comment						
FS_ID:14393						
DS_ID:22610						
EP_NO: N/A						
Repair Type: Non-Urgent						
Crossing Status: Found						
UCIP Comments: - needs repair of concrete piers on waterside. Rebar exposed from the pier. Even though this pier is functionally not linked to the pipe, it needs repair.						
FIELD_STRUCT_DESC: 5 of 8: A 24-inch pipe through levee, 25 ft. below the levee crown. Five 5-foot-by-7-foot concrete tunnels through the levee, 25.0 feet below the crown, one tunnel has a 60-inch pump installed inside and is gated on the waterward end, two 50-inch pipes through the levee, 25.0 feet below the crown, all tunnels and pipes are gated, concrete headwall and railing along the landward side (R.D. No. 1001)						
FS Date: 5/15/2013

Location of pipes and tunnels. 24-inch steel pipe located at 5th from the left.

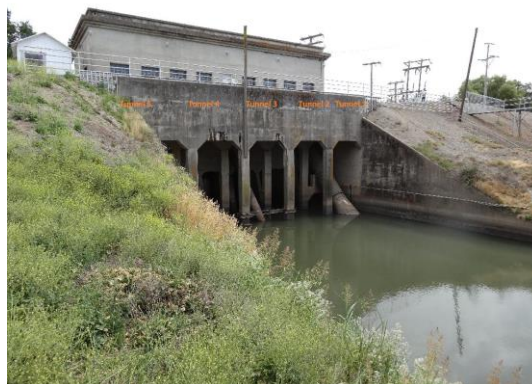
Photo 2 of 2 : UCIP_FA_2016_14393_23696.jpg

Comment Code						
Inspector Comment						
FS_ID:14393						
DS_ID:22610						
EP_NO: N/A						
Repair Type: Non-Urgent						
Crossing Status: Found						
UCIP Comments: - needs repair of concrete piers on waterside. Rebar exposed from the pier. Even though this pier is functionally not linked to the pipe, it needs repair.						
FIELD_STRUCT_DESC: 5 of 8: A 24-inch pipe through levee, 25 ft. below the levee crown. Five 5-foot-by-7-foot concrete tunnels through the levee, 25.0 feet below the crown, one tunnel has a 60-inch pump installed inside and is gated on the waterward end, two 50-inch pipes through the levee, 25.0 feet below the crown, all tunnels and pipes are gated, concrete headwall and railing along the landward side (R.D. No. 1001)						
FS Date: 5/15/2013

LS- Drainage structure with tunnels, pipes and pump house. Tunnel 1 at far right and tunnel 5 at far left. The pipe is located inside tunnel 3.

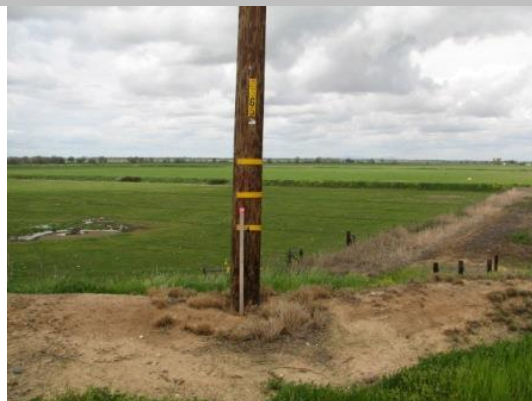
Photo 1 of 2 : FA_2016_RD1001_39_6_20160906_00003.jpg

LM Start	1.14	Rating **	A	Issue No.	6
LM End	1.14	Issue Type +	En	Location *	LS
Category	Earthen Levee			GPS Latitude/Longitude	
				Start	End
Item	Encroachments			38.793613 °	38.793613 °
				-121.592230 °	-121.592230 °
DWR ID	DWR_RD1001_05_s_2012_6				
Comment Code					
PO : Pole					
Inspector Comment

Pole on land side shoulder.

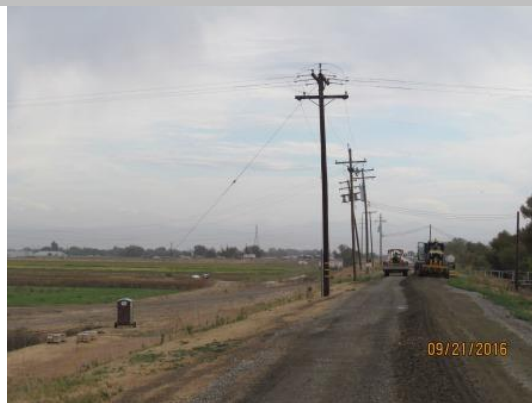
Photo 1 of 1 : FA_2016_RD1001_39_7_20160923_00035.jpg

LM Start	3.56	Rating **	M	Issue No.	7
LM End	3.81	Issue Type +	En	Location *	LS
Category	Earthen Levee			GPS Latitude/Longitude	
				Start	End
Item	Encroachments			38.814919 °	38.817178 °
				-121.556712 °	-121.552965 °
DWR ID	DWR_RD1001_05_s_2012_7				
Comment Code					
PO : Pole					
Inspector Comment

View of poles on the landside shoulder looking downstream. Fall 2016

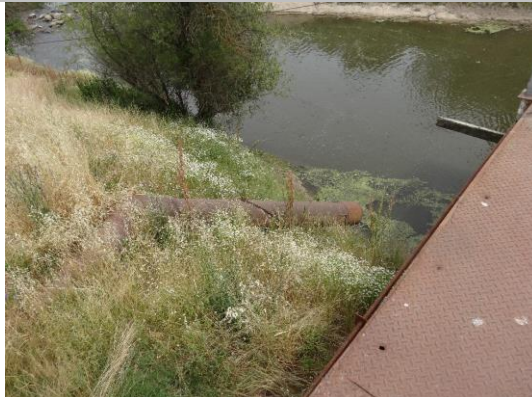
Photo 2 of 2 : UCIP_FA_2016_14486_23912.jpg

Comment Code					
Inspector Comment					
FS_ID:14486					
DS_ID:22604					
EP_NO: 1896					
Repair Type: Non-Urgent					
Crossing Status: Found					
UCIP Comments: - slide gate in concrete box on waterside levee toe.- cracked headwall on landside- working during field survey- abandoned steel pipe, may need to remove it or properly adandoned.					
FIELD_STRUCT_DESC: 3 of 3: Abandoned 20-inch pipe of three pipes, a 30-inch and two 20-inch corrugated-metal asbestos-bonded pipe through the levee, 2.13 feet below the crown, three vertical pumps on a wooden piling structure in the stream, walkway to the pumps, slide gate in a concrete box on the waterward side (Permit No. 1896)					
FS Date: 5/15/2013

WS- abandoned pipe adjacent to pump station on stream bank.
